NATIONAL TRANSPORTATION SAFETY BOARD

HIGHWAY/RAILROAD ACCIDENT REPORT

**Collision of Northeast Illinois Regional Commuter
Railroad Corporation (METRA) Train and
Transportation Joint Agreement School District 47/155
School Bus at Railroad/Highway Grade Crossing
in Fox River Grove, Illinois, on October 25, 1995**

NTSB/HAR-96/02 (PB96-916202)

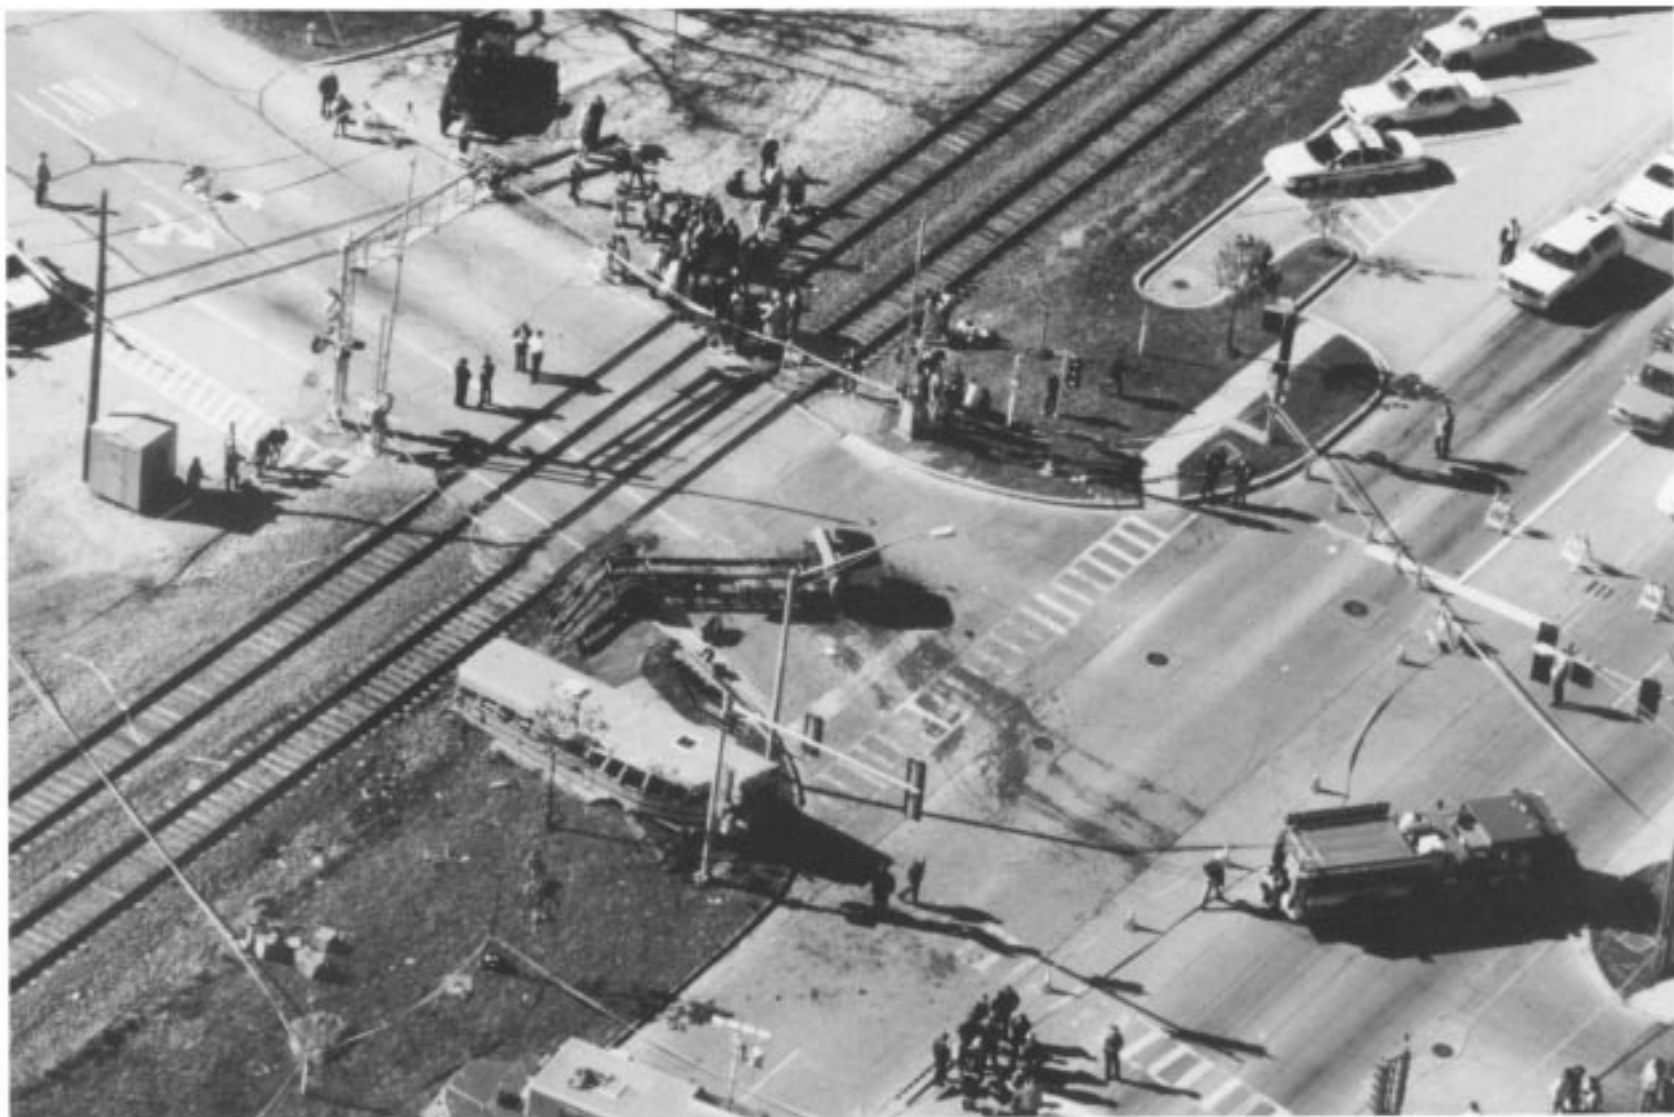
Figure 2 — Accident scene

The inward deformation of the left rear side of the school bus extended along the last 105 inches (8.75 feet) of the bus to a maximum of 40 inches at the left rear corner. Contact damage and light gray paint transfers were found at the left rear corner and extended 36 inches toward the front. The left rear tire was punctured and the same light gray paint transfer was found on the tire. (The train was painted light gray.) The rear frame members of the chassis were bent rightward (the direction the train was going) at approximately a 41-degree angle (with the left side chassis frame rail bent 82 inches). The left side floor had separated between rows 7 and 8. The bus body from the cowling rearward (just in front of the driver's position) had separated from the chassis during impact. The right side of the bus sustained buckling inward between rows 7 and 10, extending from the roof down the entire side wall. A 2 ½-inch-long scratch was found above the 10th window on the left side of the bus. A dent with a yellow paint transfer similar to the yellow paint on the traffic signal stanchion was above and to the right of the 10th window on the right side of the bus.

The windshield and eight of the left side windows were completely broken out, and the left side window frames were skewed and buckled. Although the right side window frames

were bent inward and buckled, the glass in 10 of the 13 windows was intact. The right front entrance door had been torn from all but one of its front hinges and was lying partially inside the entranceway. The rear emergency roof hatch was dislodged. The rear emergency door had buckled severely and was partially open after the accident. Scrapes were found on the top and right side of the fuel tank; however, it was not punctured, nor was there any leakage.

The interior of the roof was deformed inward and upward in the rear. The left side seatbacks in rows 9 through 12 were displaced rearward. The right side seats in rows 8 through 12 were either warped, raised upward, displaced leftward, or missing seat cushions. The left side seat in row 12 was displaced inward 17 inches from the sidewall to the center of the bus.

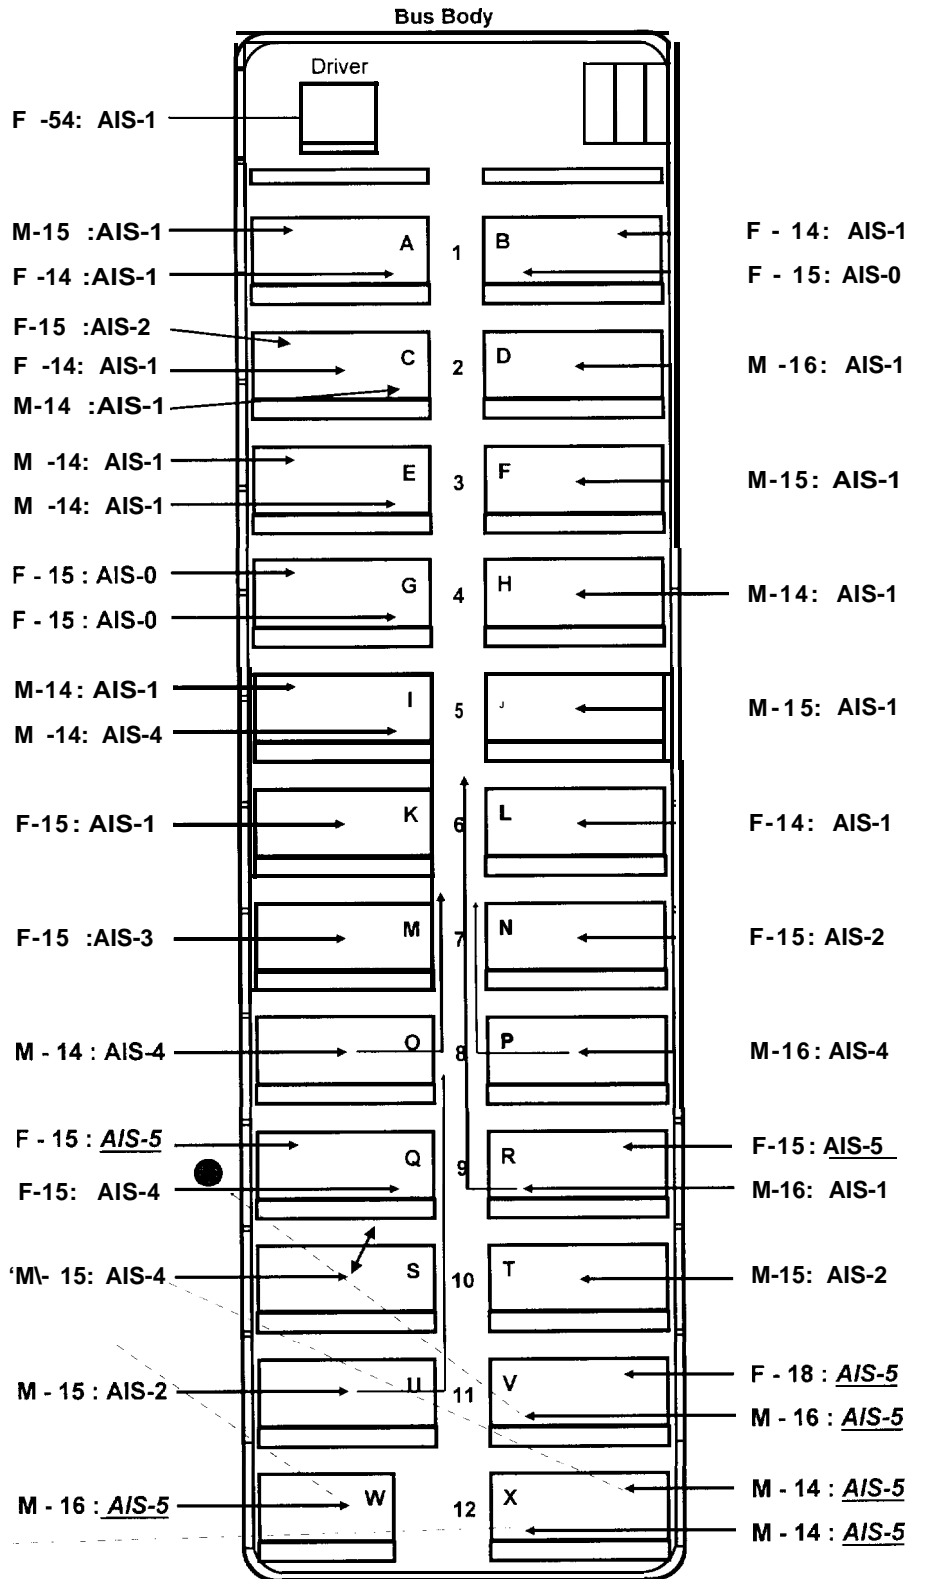
Figure 3 — School bus occupant seating and injury distribution diagram

According to witness statements, five passengers seated in rows 8 through 11 stood up before the collision. One passenger was standing at his seat in row 10 when the collision occurred. The other four had reportedly moved into the aisle and were attempting to move forward in the bus. They were found in the aisle near rows 6 and 7 after the accident. Four of the five passengers who stood sustained moderate to severe injuries and one passenger sustained minor injuries.

The minor to moderately injured passengers, who were seated primarily in rows 1 through 8, sustained concussions, contusions, lacerations, abrasions, and fractures of the head and extremities. The severely injured passenger in row 5 sustained lung contusions, a skull fracture, and a brain injury. The seriously injured passenger in row 7 sustained a concussion, a skull fracture, and a contusion of his

spleen. The severely injured passengers seated in rows 8, 9, and 10 sustained multiple contusions, lacerations, and fractures of the head, shoulders, and extremities, and blunt trauma to the internal organs, such as the lungs, spleen, kidneys, and liver.

The fatally injured passengers, who were seated in rows 9, 11, and 12, sustained multiple fractures to the head and pelvis, and contusions and lacerations to the internal organs, such as the pancreas, liver, kidneys, spleen, and lungs. All seven of the fatally injured passengers sustained severe skull fractures (some with facial bone fractures) with subsequent massive brain injuries. A circular 0.2- to 0.5-inch abrasion was noted on the forehead of one fatally injured passenger and another had a 1.2- by 2-inch L-shaped abrasion on the left side of the head. The interior window frames and the perforated sound panels inside the school bus were shaped similarly to these abrasions.

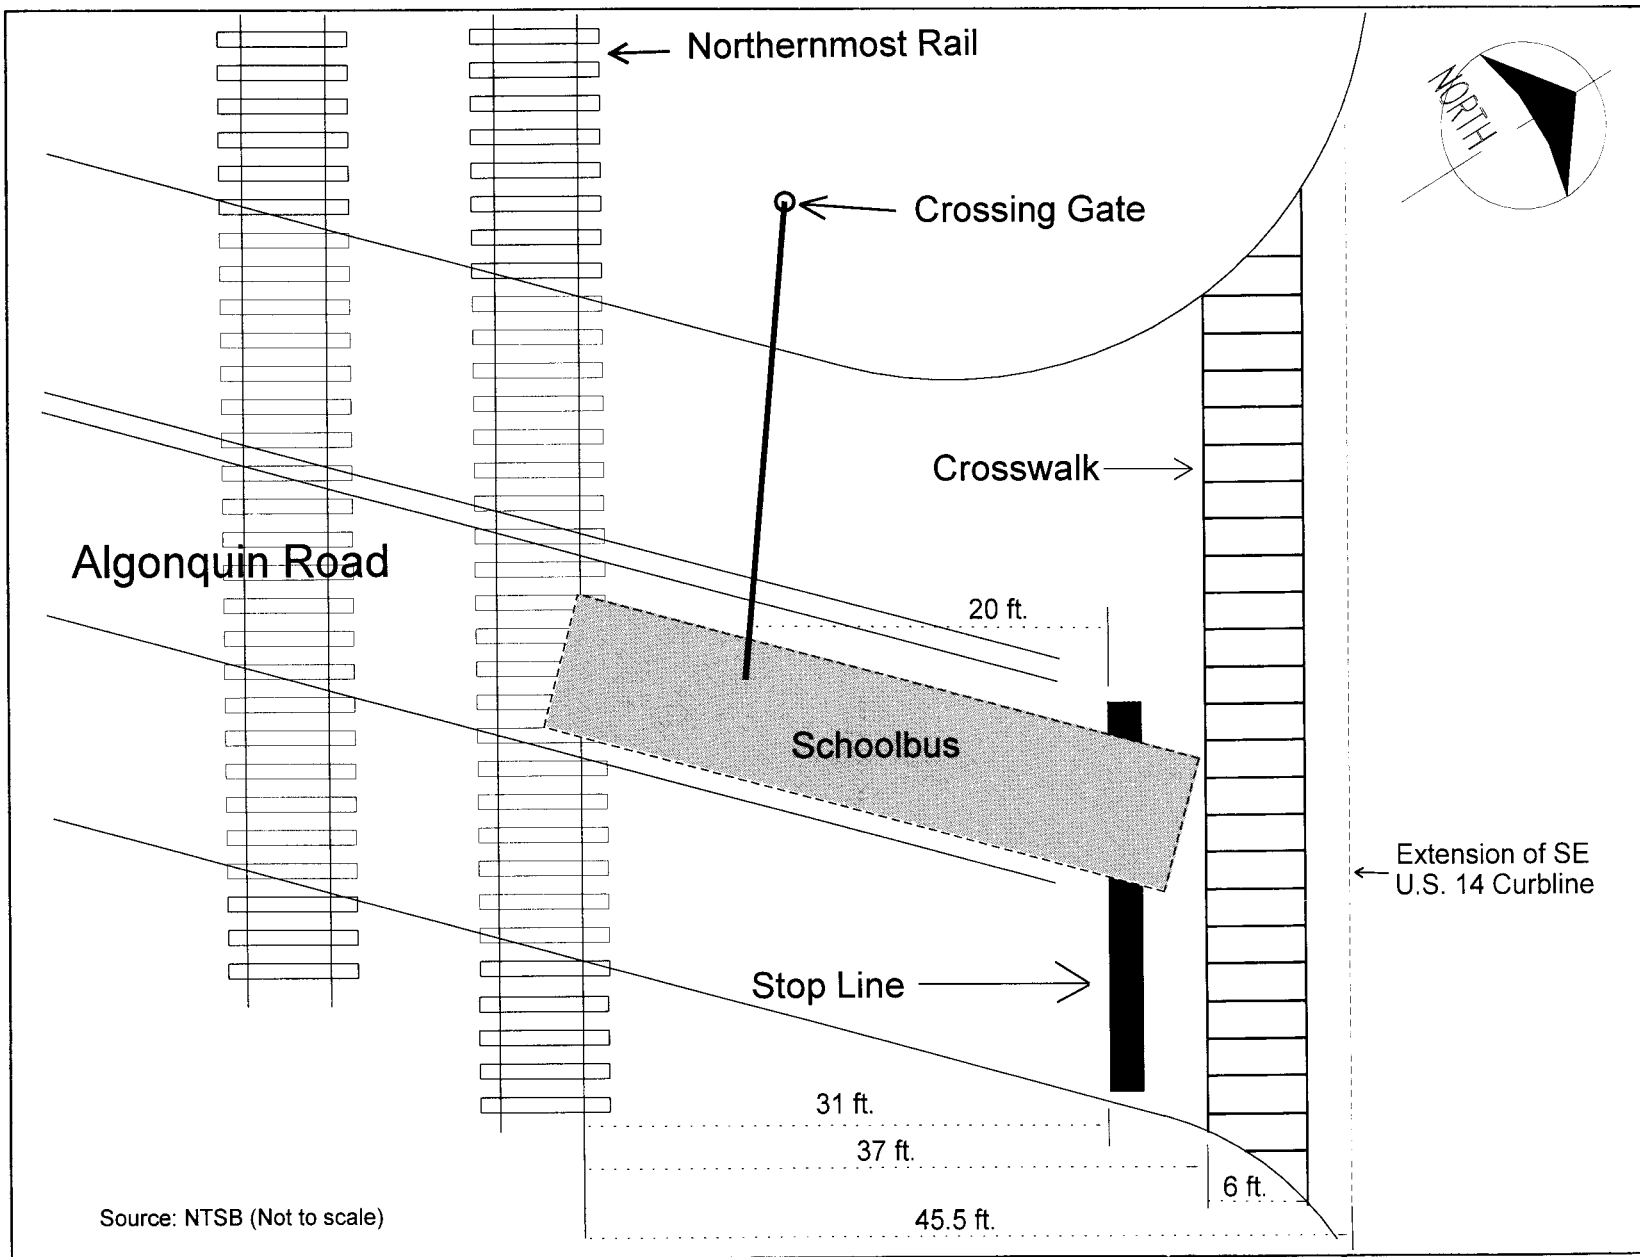
Figure 5 — Diagram of queuing area

feet long. In 1989, IDOT widened US 14 using about 35 feet of railroad property, thereby shortening this area to about 45 feet. In addition, IDOT widened the Algonquin Road approach to the intersection from a two-lane to a three-lane roadway, adding a left turn lane for northbound traffic.

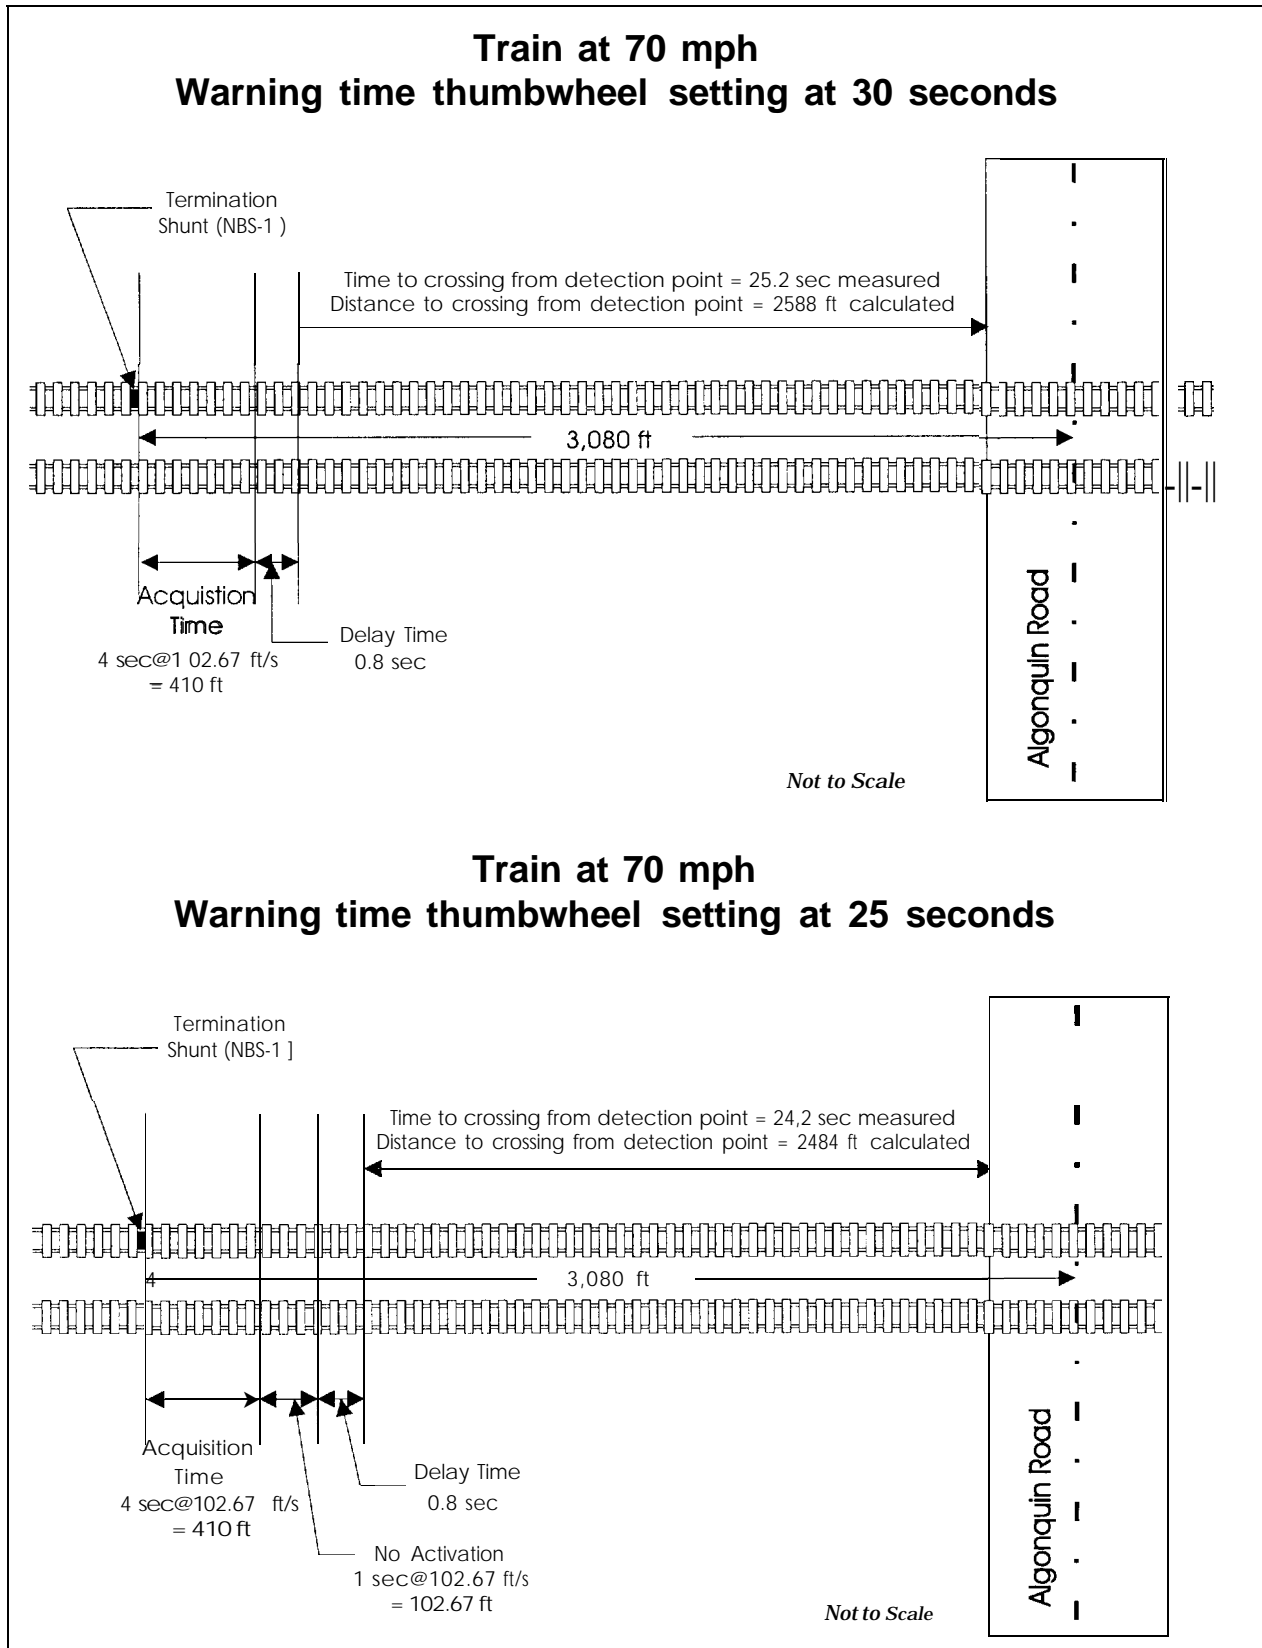
Figure 6 – Warning times for train at 70 mph

¹⁸ A lag time of about 8/10 second elapses before the grade crossing signal is activated, meaning a thumbwheel setting of 30 seconds at 3,080 feet produces 25 seconds rather than 26 seconds of railroad signal operation. A thumbwheel setting of 25 seconds actually produces 24 seconds. (See Tests and Research Section.)
