NATIONAL TRANSPORTATION SAFETY BOARD

HIGHWAY/RAILROAD ACCIDENT REPORT

**Collision of Northeast Illinois Regional Commuter
Railroad Corporation (METRA) Train and
Transportation Joint Agreement School District 47/155
School Bus at Railroad/Highway Grade Crossing
in Fox River Grove, Illinois, on October 25, 1995**

NTSB/HAR-96/02 (PB96-916202)

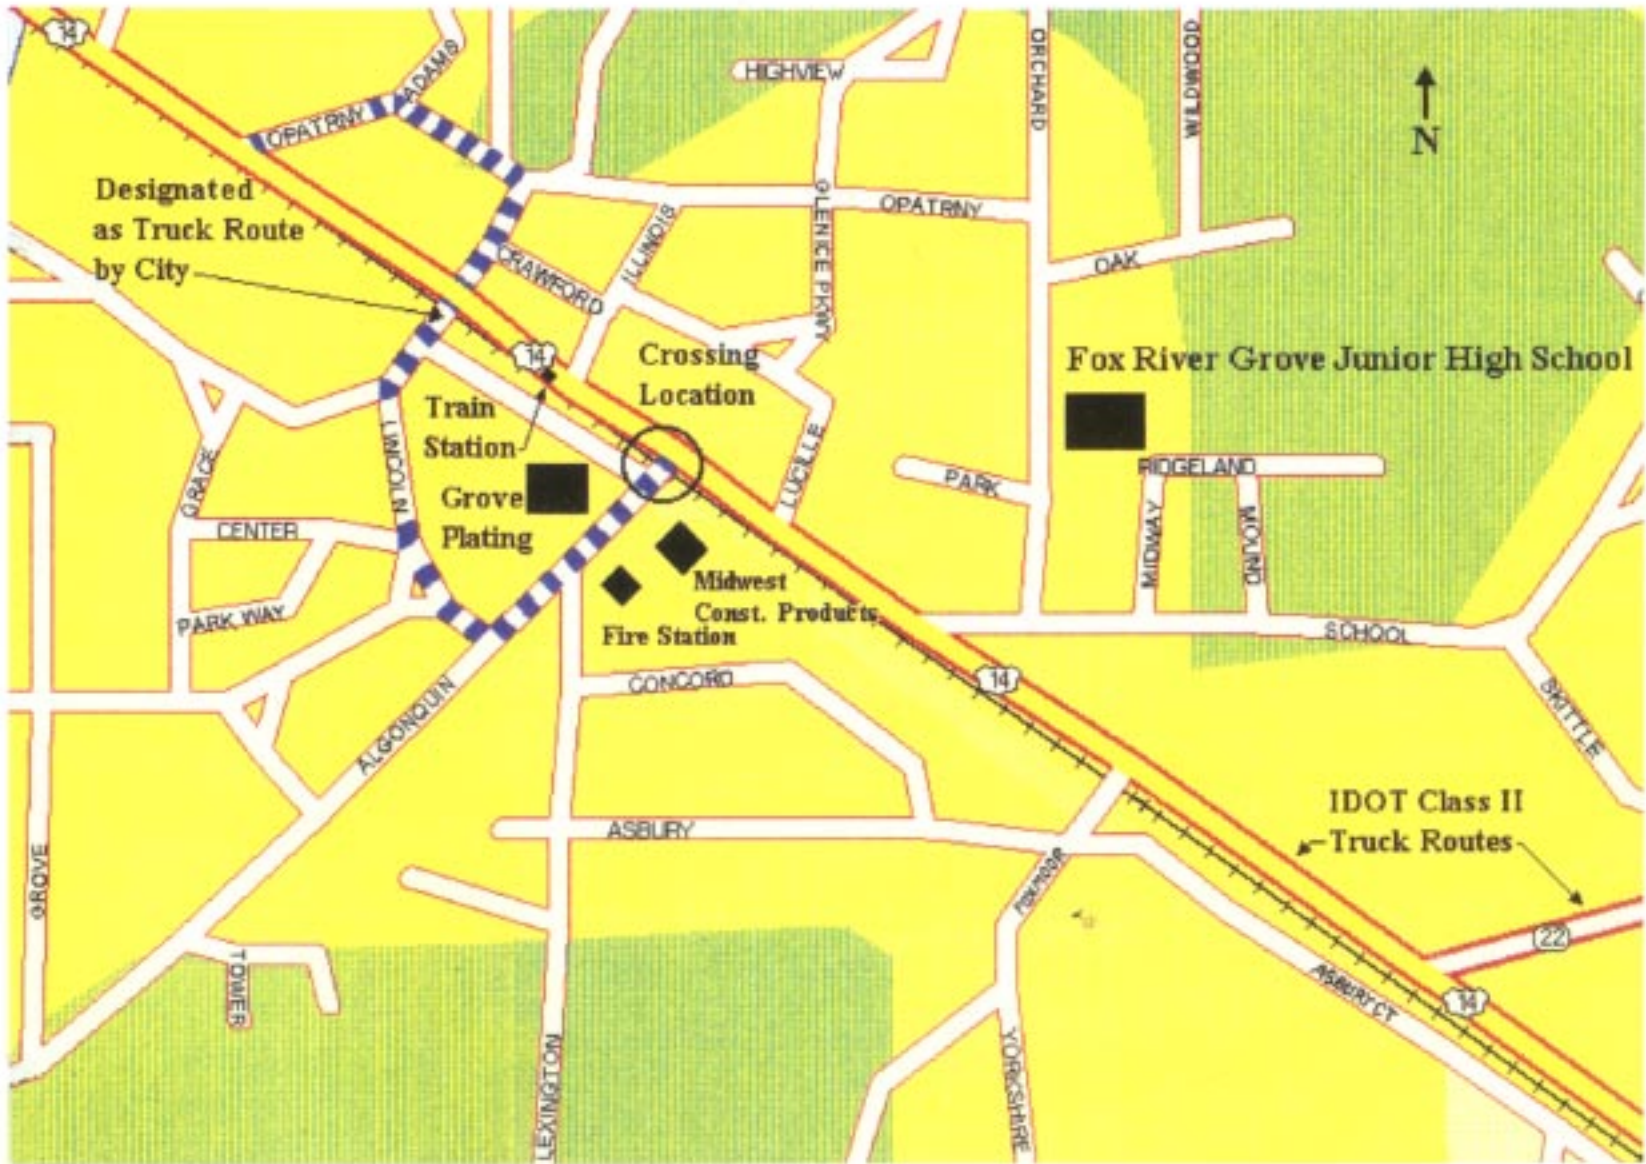
Figure 1 — Map of accident showing route of bus (dotted line).

She made her first stop to pick up passengers at 6:55 a.m. Because she was not familiar with the stops on the route and the map was difficult to read in the predawn darkness, she asked one of these initial passengers to assist her with the route, and he agreed to do so. She had completed all but one stop on the route as the bus approached the grade crossing at Algonquin Road, where she stopped it on the south side of the crossing, activated the hazard lights, opened the bus door, and looked right and left. She said that she did not see a train and therefore closed the door and proceeded over the railroad tracks. The passenger assisting the busdriver was seated directly behind her and said that he looked both ways and saw no train.

A traffic signal system controls the intersection at Algonquin Road and US 14. Two railroad tracks cross Algonquin Road about 45 feet south of US 14. The railroad/highway grade crossing is equipped with active crossing warning devices (gates, lights, and bell). Loop detectors,² designed to detect the presence of vehicles, are embedded in the pavement on the north and south sides of the tracks.

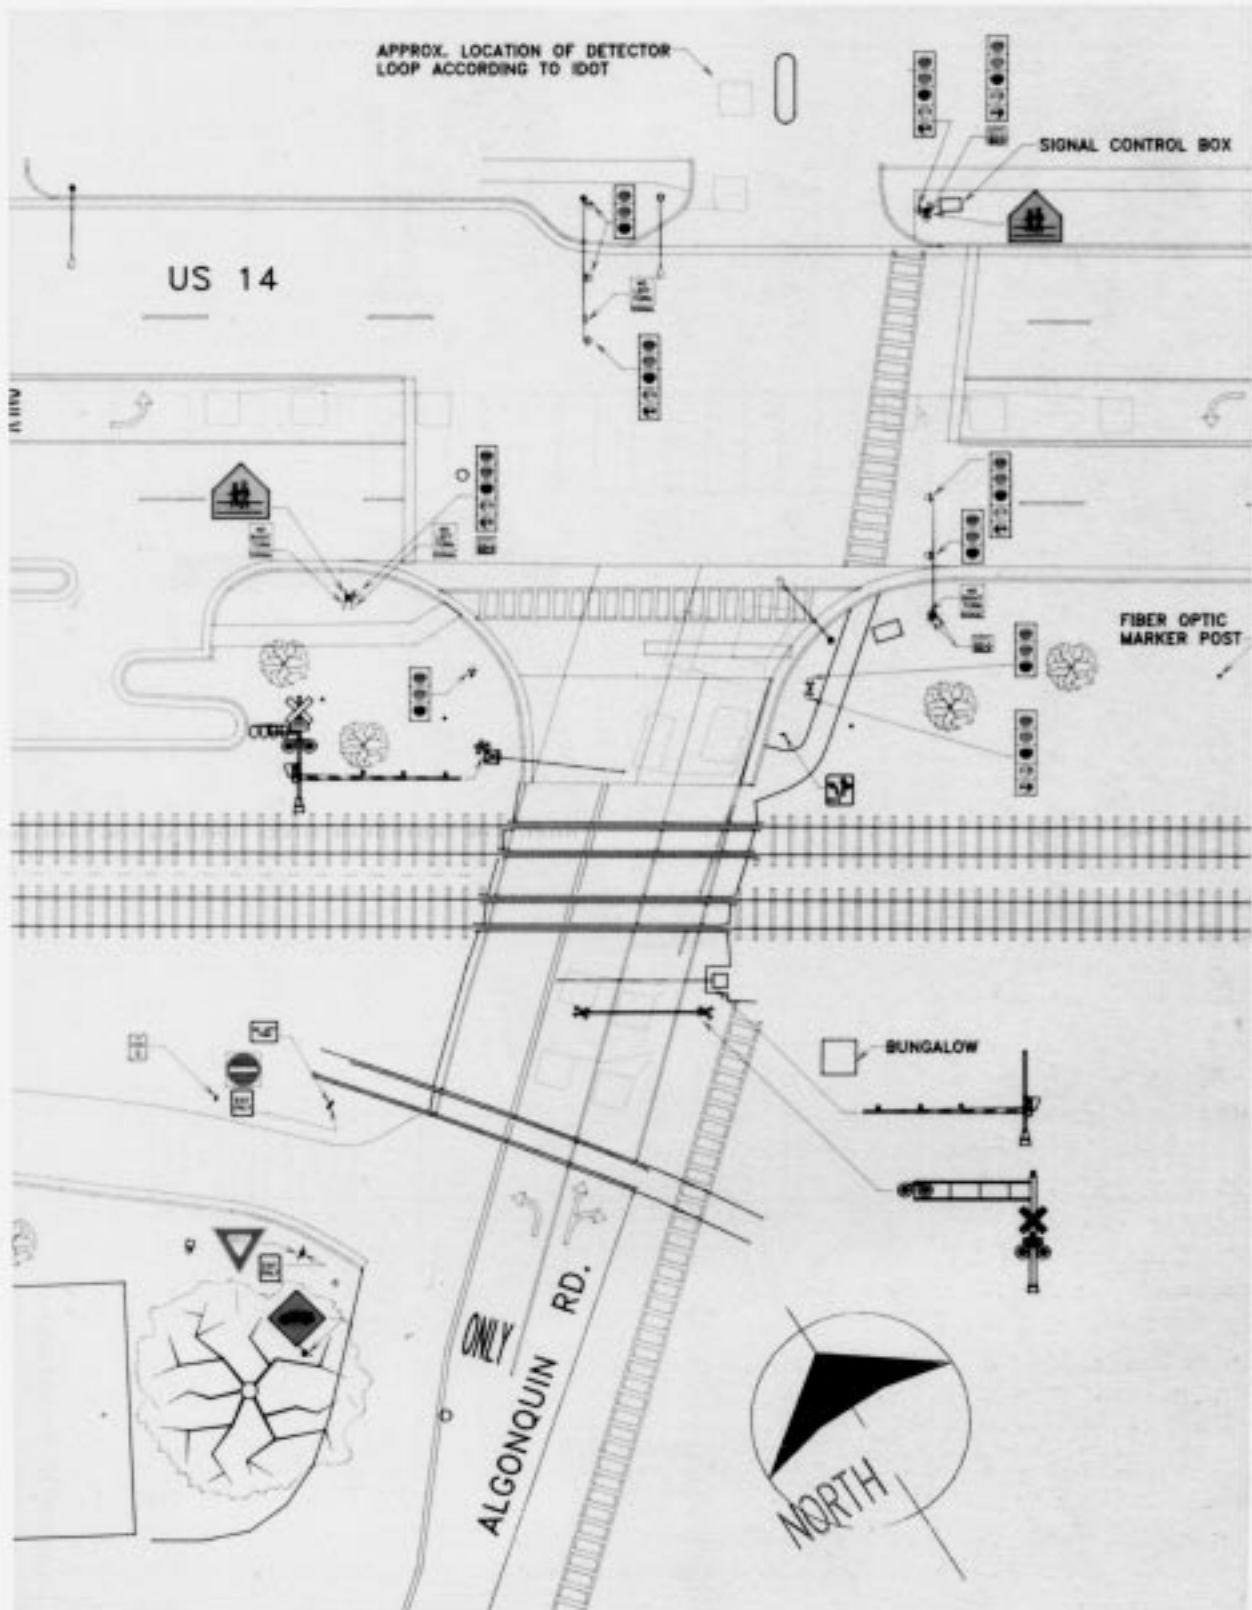
Figure 4 — Diagram of accident site (Courtesy of Safety Engineering Associates, Inc.)

Algonquin Road intersects the railroad tracks and US 14 at a 75-degree angle. Eighty feet south of the grade crossing, the northbound approach is a 2.5 percent upgrade that transitions to a 7.7 percent upgrade leading up to the grade crossing. Between the railroad tracks and US 14, the roadway slopes down 7.8 percent. The roadway is level 9 feet north of and 3 feet south of the outer rails. (See figures 4 and 5.)
